MISCELLANEOUS PAPER S-73-16

CONDITION SURVEY, ROBERT GRAY ARMY AIRFIELD, FORT HOOD, TEXAS

P. J. Vedros, R. D. Jackson

April 1973

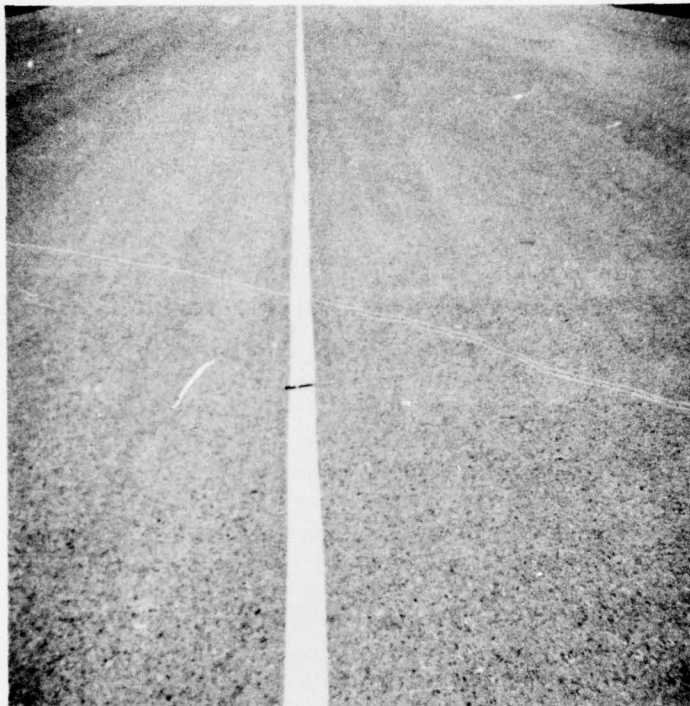
excellent condition. Photo 1 shows the generally good condition of the AC pavement of the runway (looking north from sta 56+00). Photo 2 shows a general view of the PCC pavement of the runway (looking south from sta 96+00), which was in excellent condition. A longitudinal paving lane crack near sta 56+00 is shown in photo 3. The AC portion of the parallel taxiway was in very good condition (photo 4), even though there were many skid marks from rotary-wing aircraft operations. The south parking apron was in good condition (photo 5). The north half of the PCC north parking apron was in excellent condition (photo 6). At the time of this inspection, the concrete was being poured for the south half of the apron. The pavement facilities not specifically mentioned above were in good to excellent condition.

Photo 1. AC pavement on runway looking north
from sta 56+00

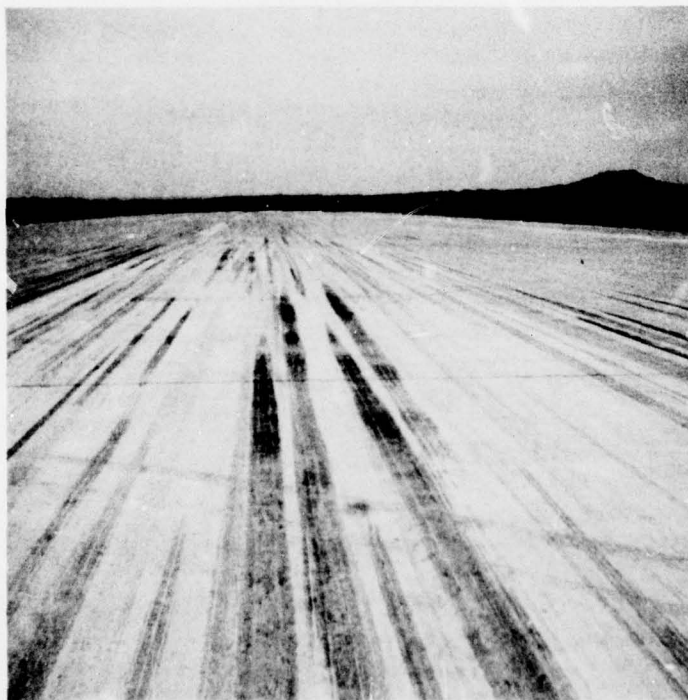
Photo 2. General view of PCC pavement on runway
looking south from sta 96+00

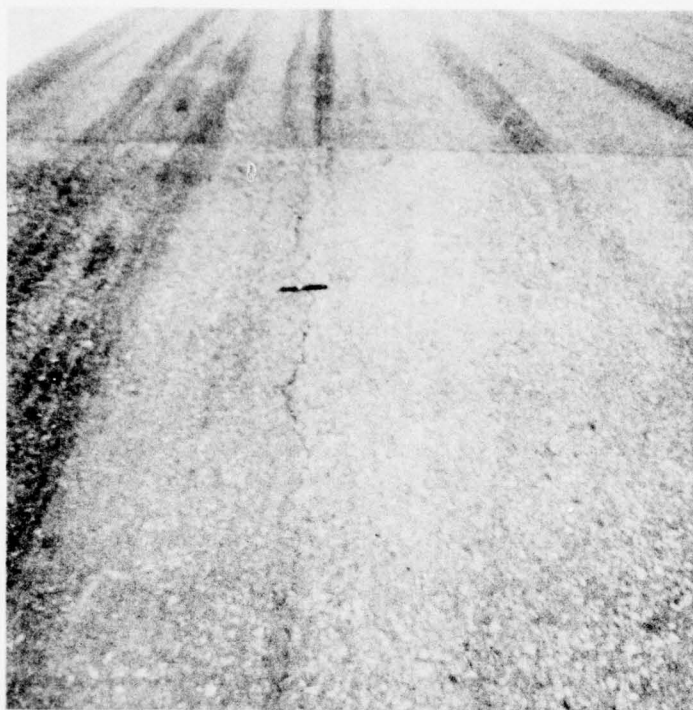
Photo 3. Paving lane crack in AC pavement near
sta 56+00

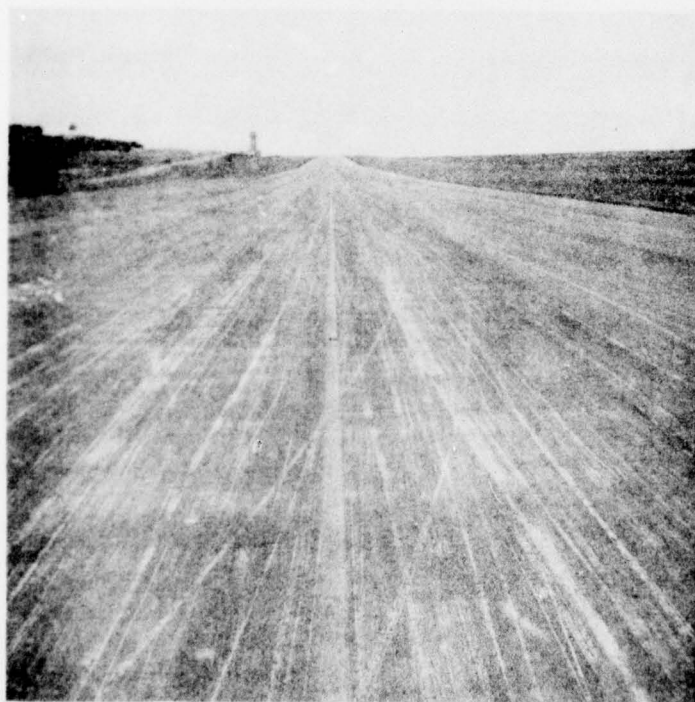
Photo 4. View of parallel taxiway showing heli-
copter skid marks

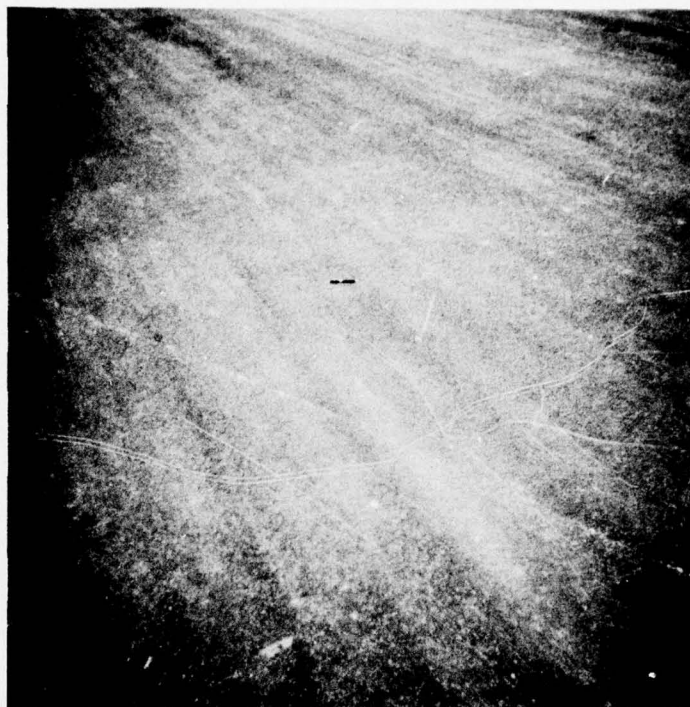
Photo 5. General view of south parking apron

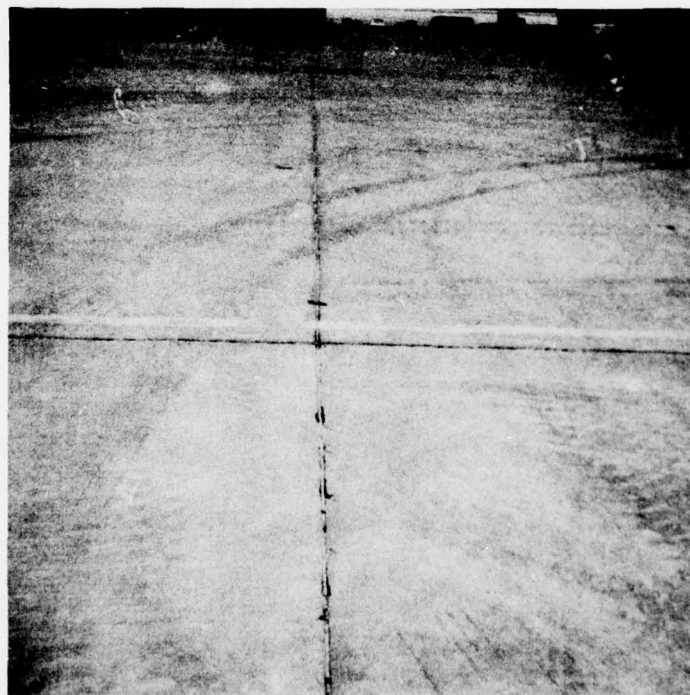
Photo 6. View of north end of north parking apron
